THERMAL BREAKAGES

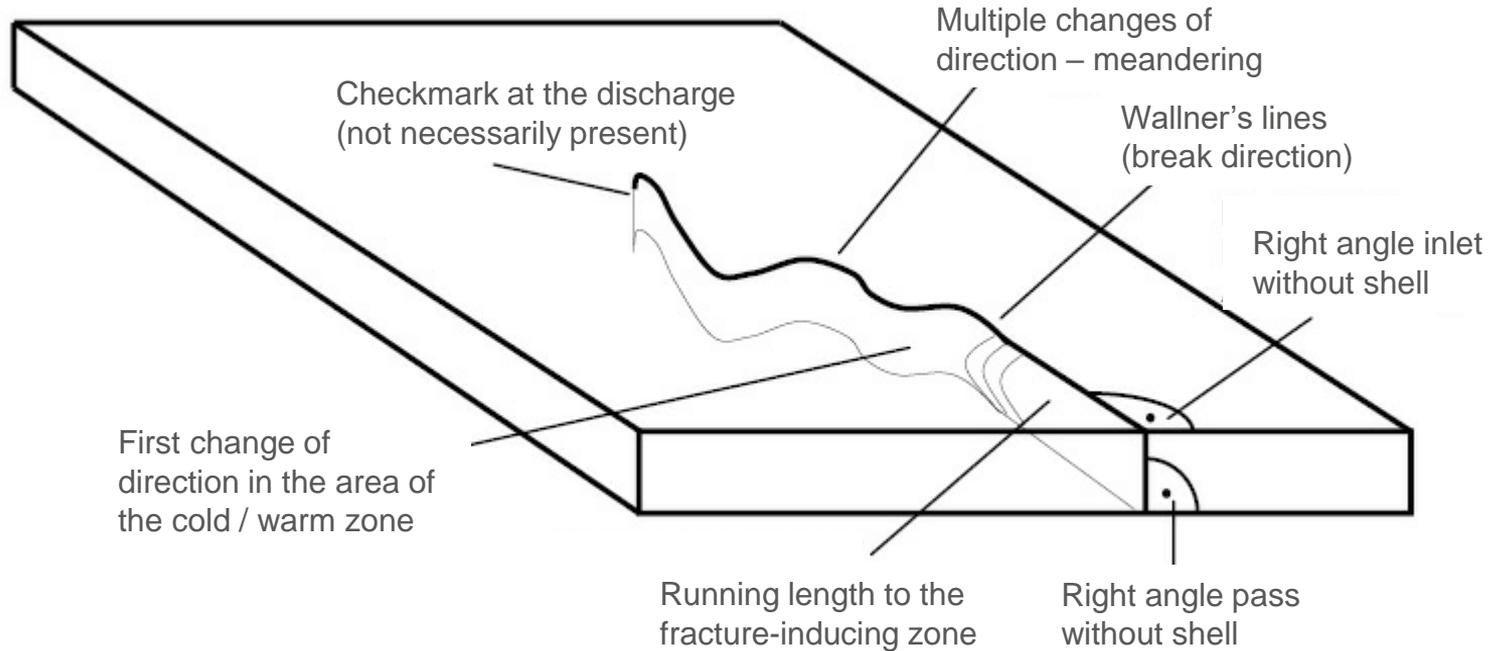
Representation of a fracture curve caused by thermal stresses in non-tempered glass.

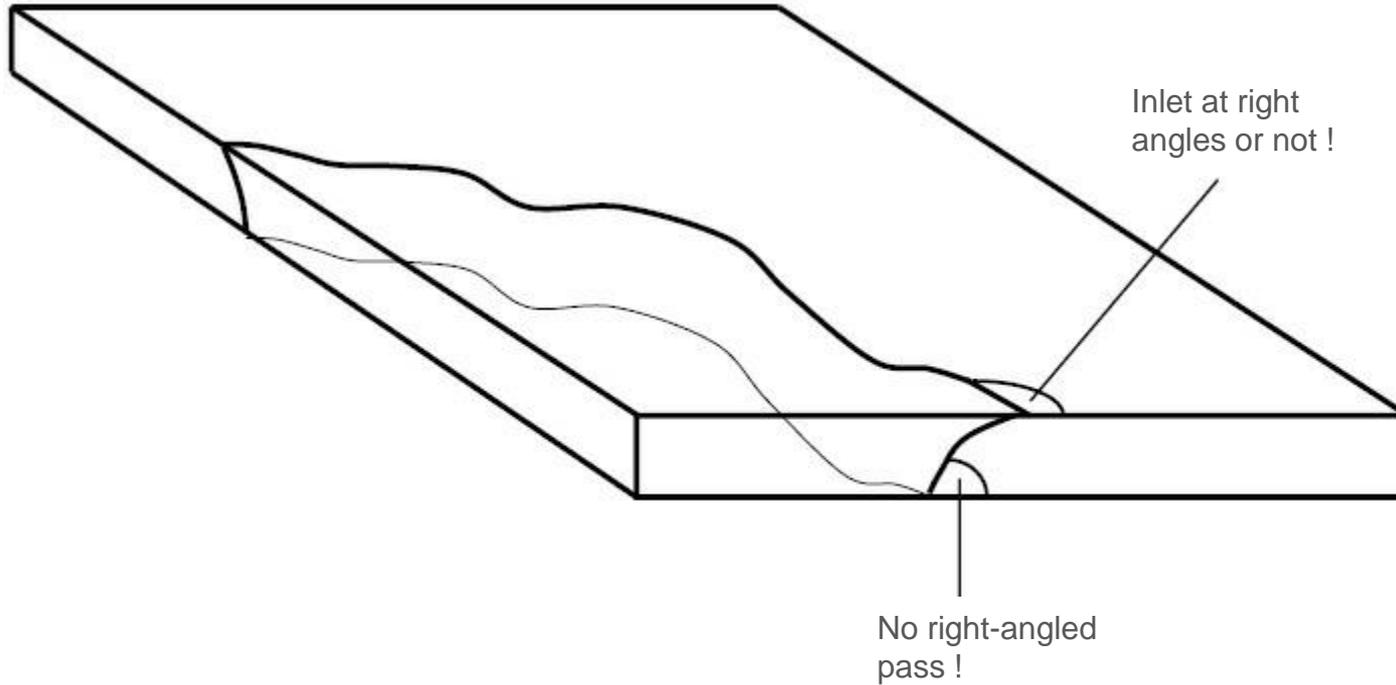
Representation of a fracture profile caused by mechanical stresses in non-tempered glass.

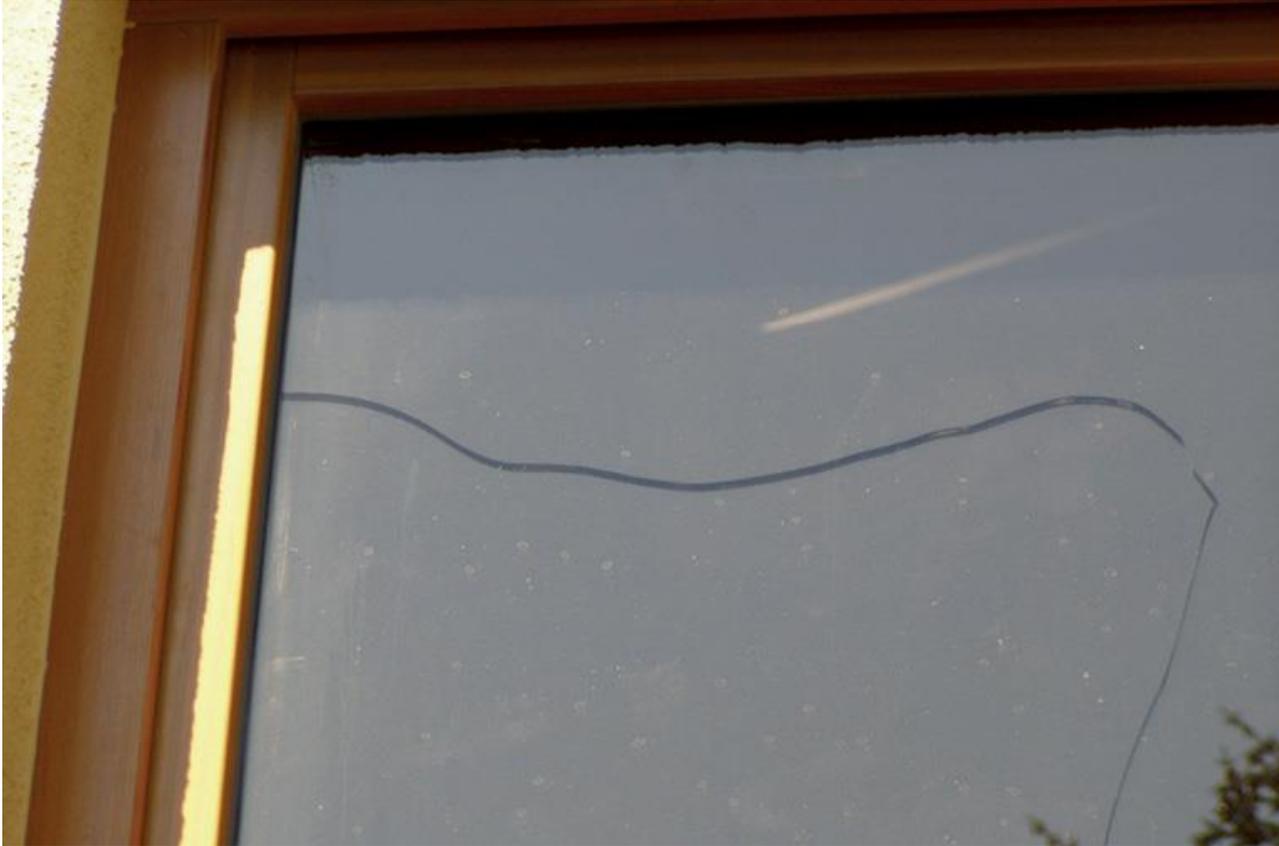
Thermal simple crack

Thermal load — weak / medium intensity

Thermal break on colored, absorbing glass, breakage on the cold / warm zone

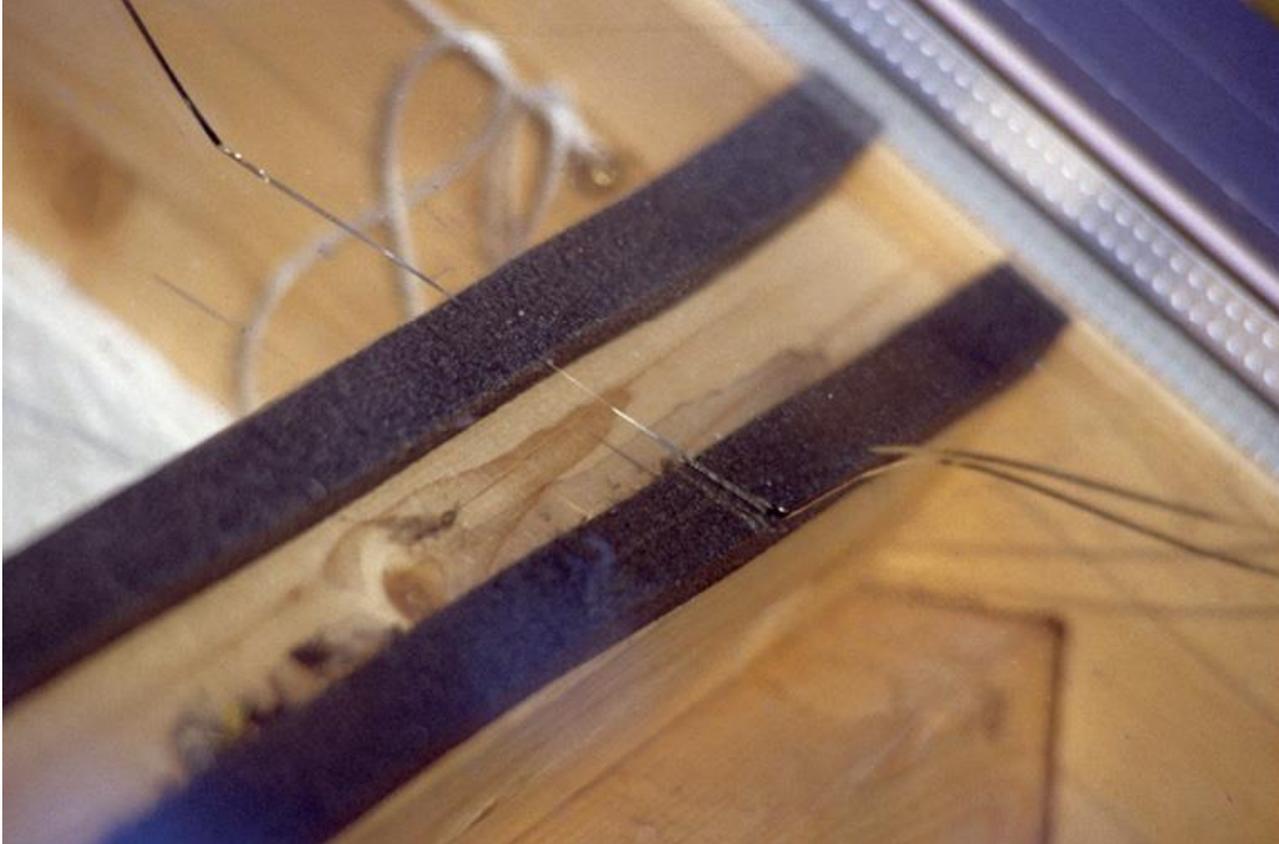
Thermal simple crack

Thermal load — weak / medium intensity

Thermal break on the lower LSG pane of insulating glass that runs from the warm zone (room), over the support (black profile = heating) to the outside area (cold zone).

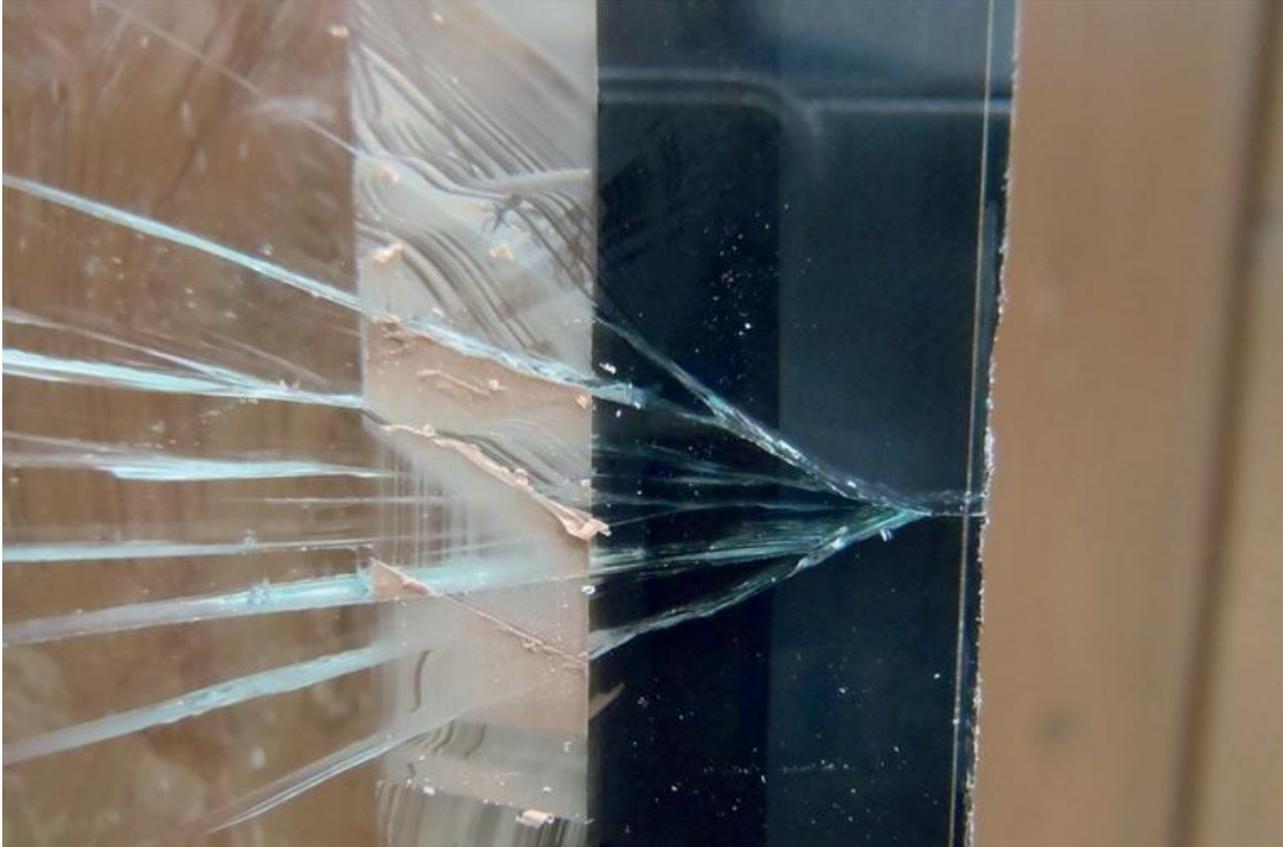
Thermal Palm / Fanning crack

Thermal point or line load - strong intensity

Thermal palm crack, caused by very strong punctual heating of the glass pane.

Clearly recognizable right-angled inlet to the glass edge with immediate splitting, due to very high stress action

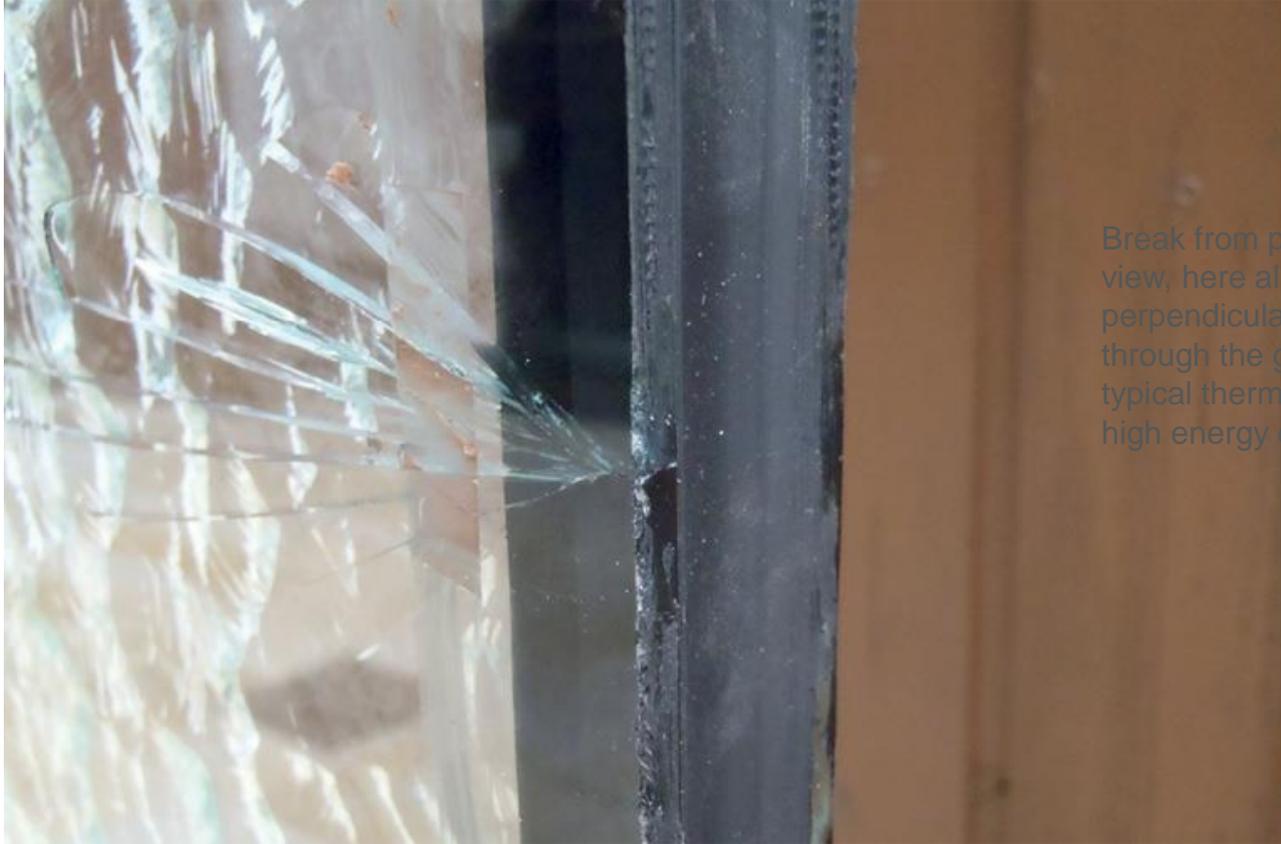
Thermal Palm / Fanning crack

Thermal point or line load - strong intensity

Break from picture above, but edge view, here also the break perpendicular to the glass surface through the glass recognizable, typical thermal break, but with very high energy effect.

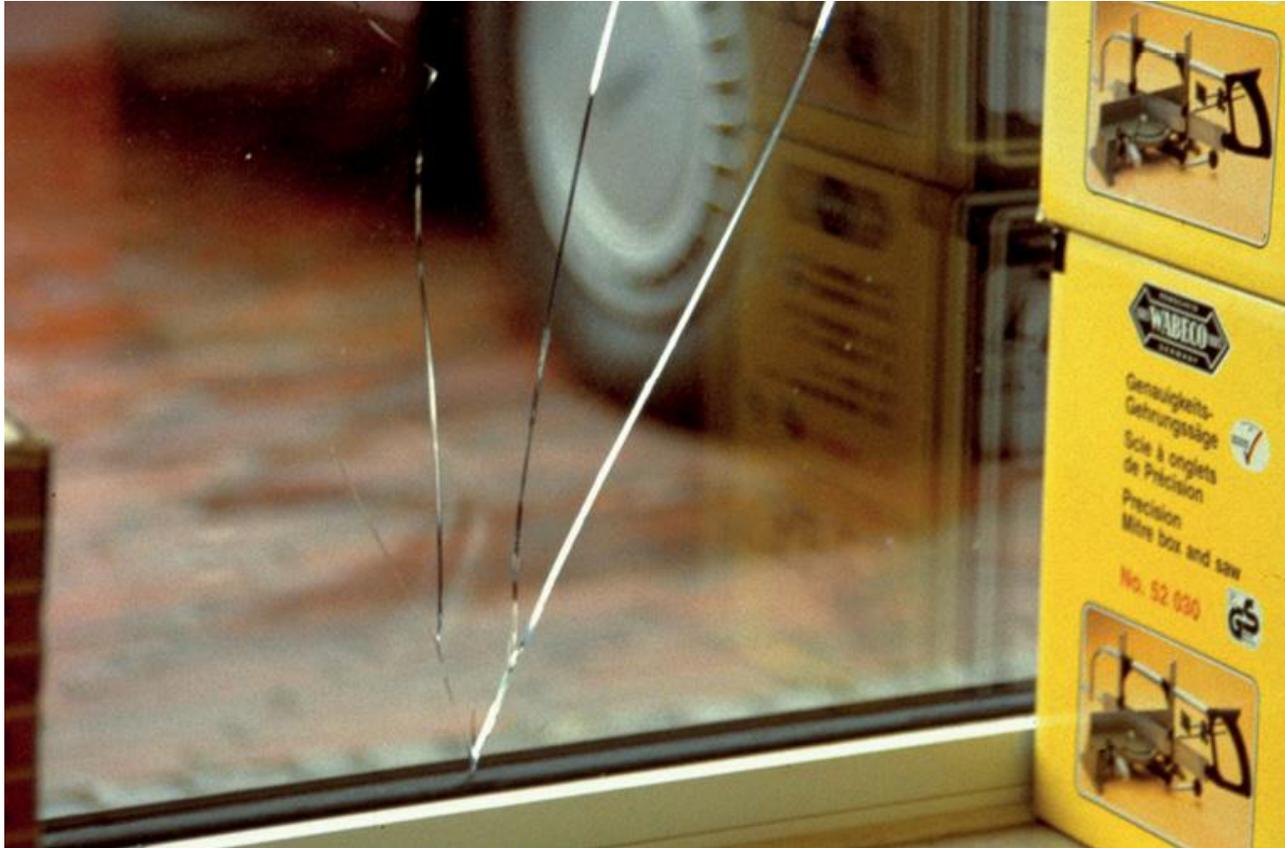
Strong thermal break

Thermal line load - strong intensity

Thermal breakage of a shop window caused by boxes stacked directly on the pane.

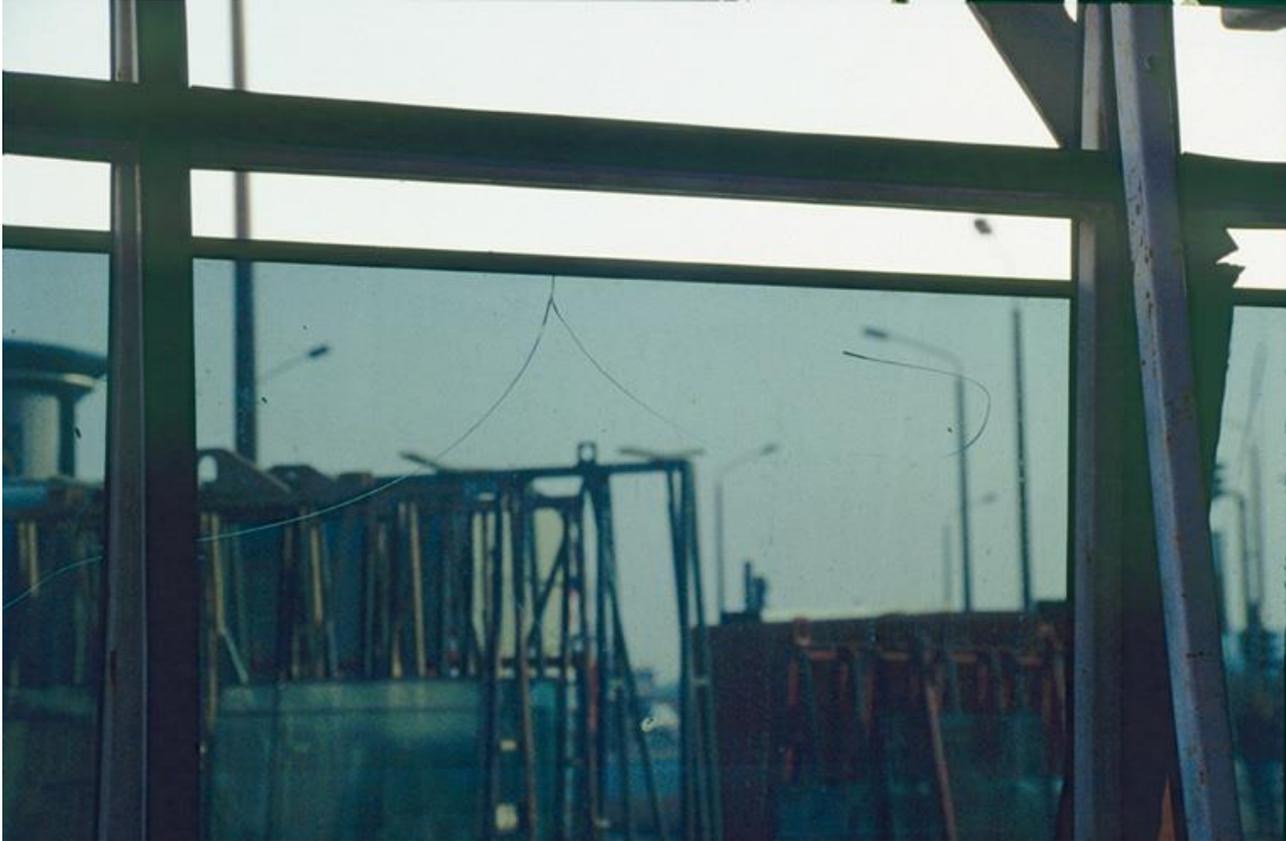
Strong thermal break

Thermal line load - strong intensity

Thermal break on non-tempered, absorbent solar control glass in IGU, on direct sun exposure.

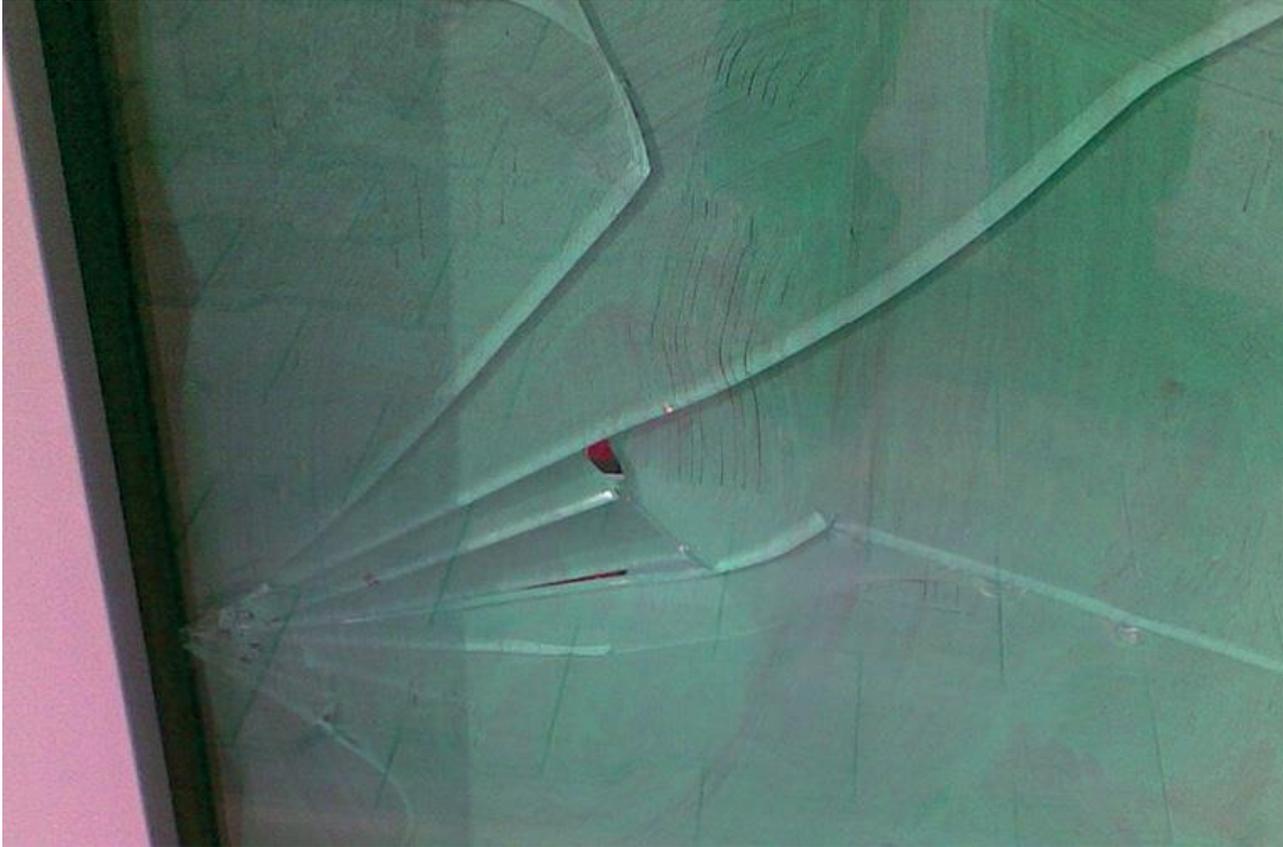
Very strong thermal break

Thermal line load - very strong intensity

Strong thermal break caused by painting of the glass pane.

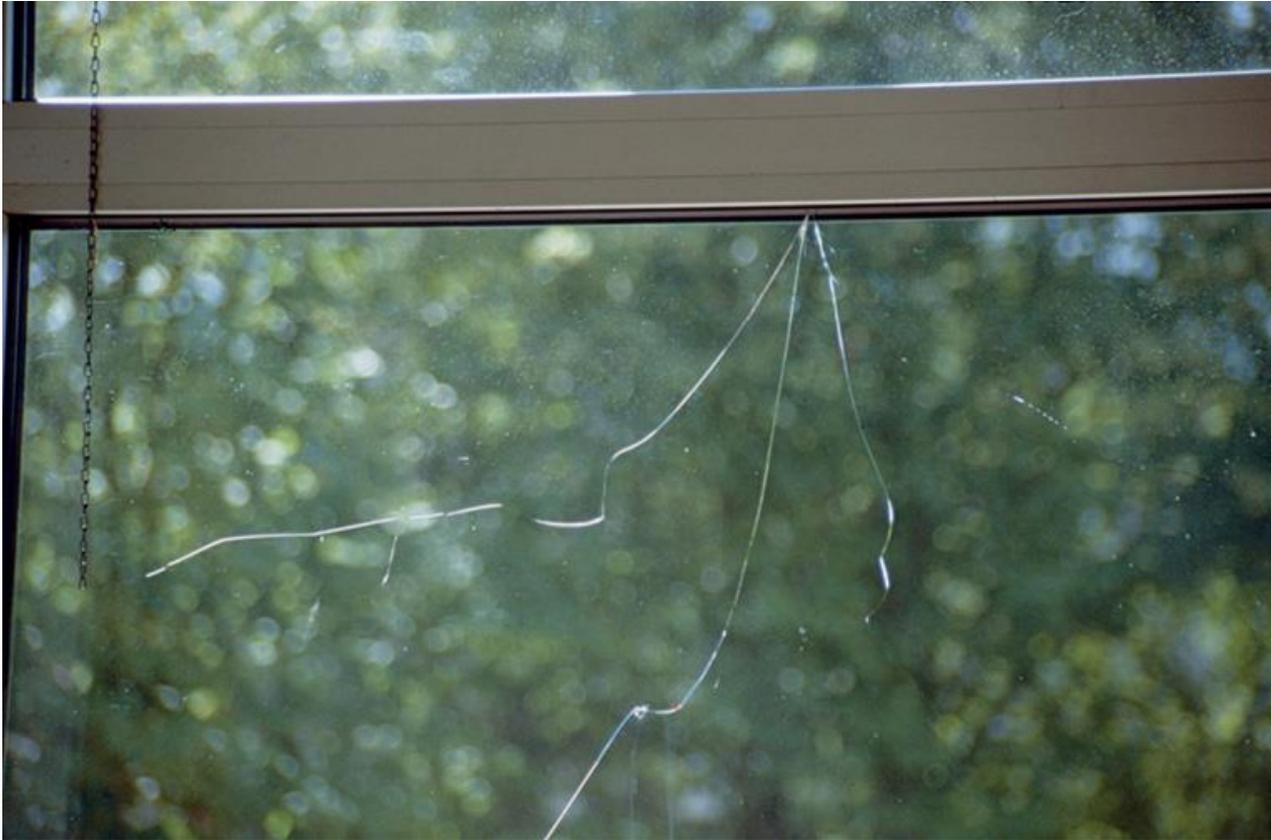
Very strong thermal break

Thermal line load - very strong intensity

Strong thermal break caused by advertising poster hung directly on the inner pane.

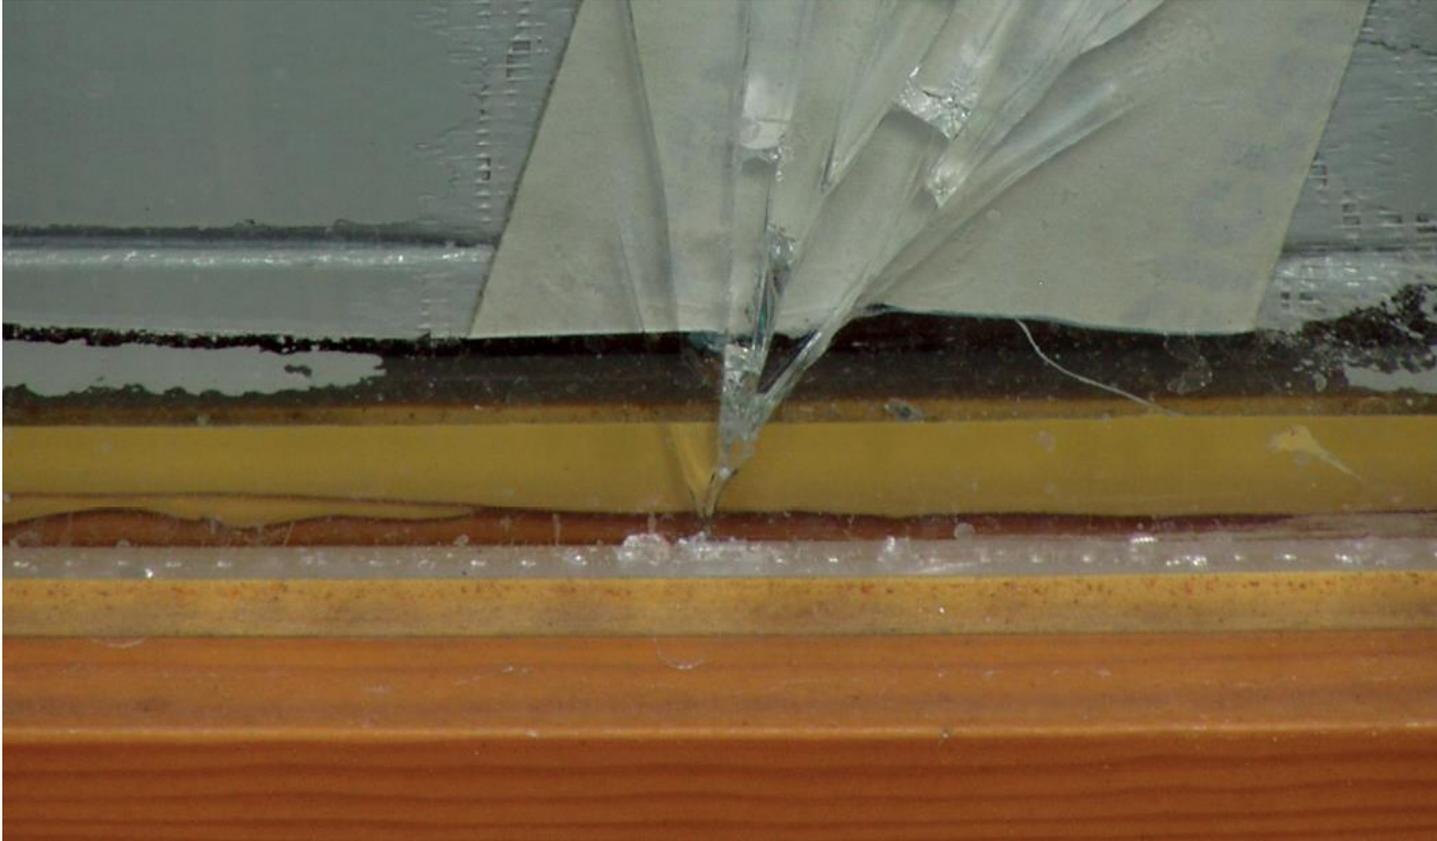
Thermal edge break

Thermal line load - medium to high intensity

Strong thermal break caused by objects placed on/next IGU (thermal insulation panel).

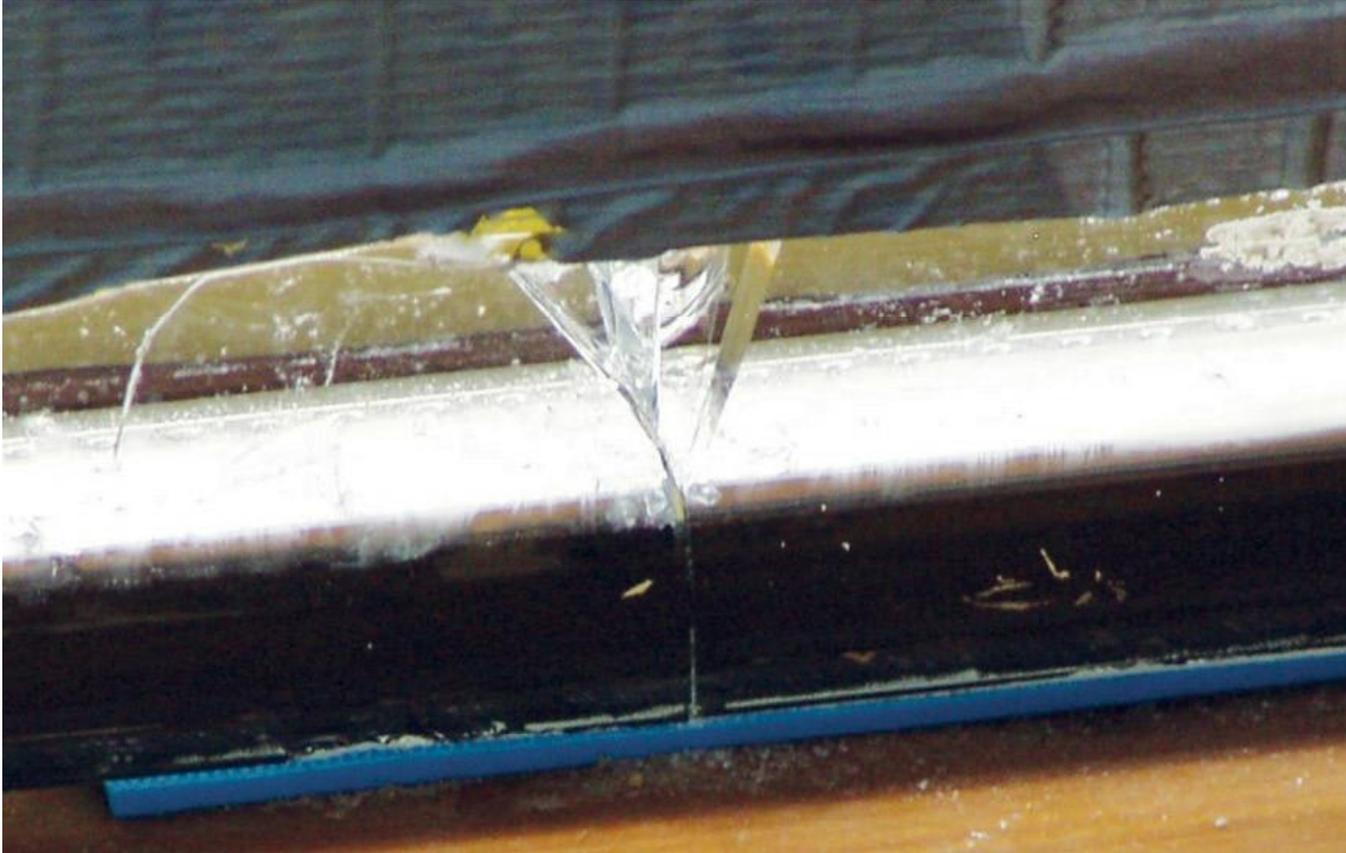
Thermal edge break

Thermal line load - medium to high intensity

Detail from the picture above, inside view with removed glazing bead clearly recognizable rectangular inlet of the thermal break

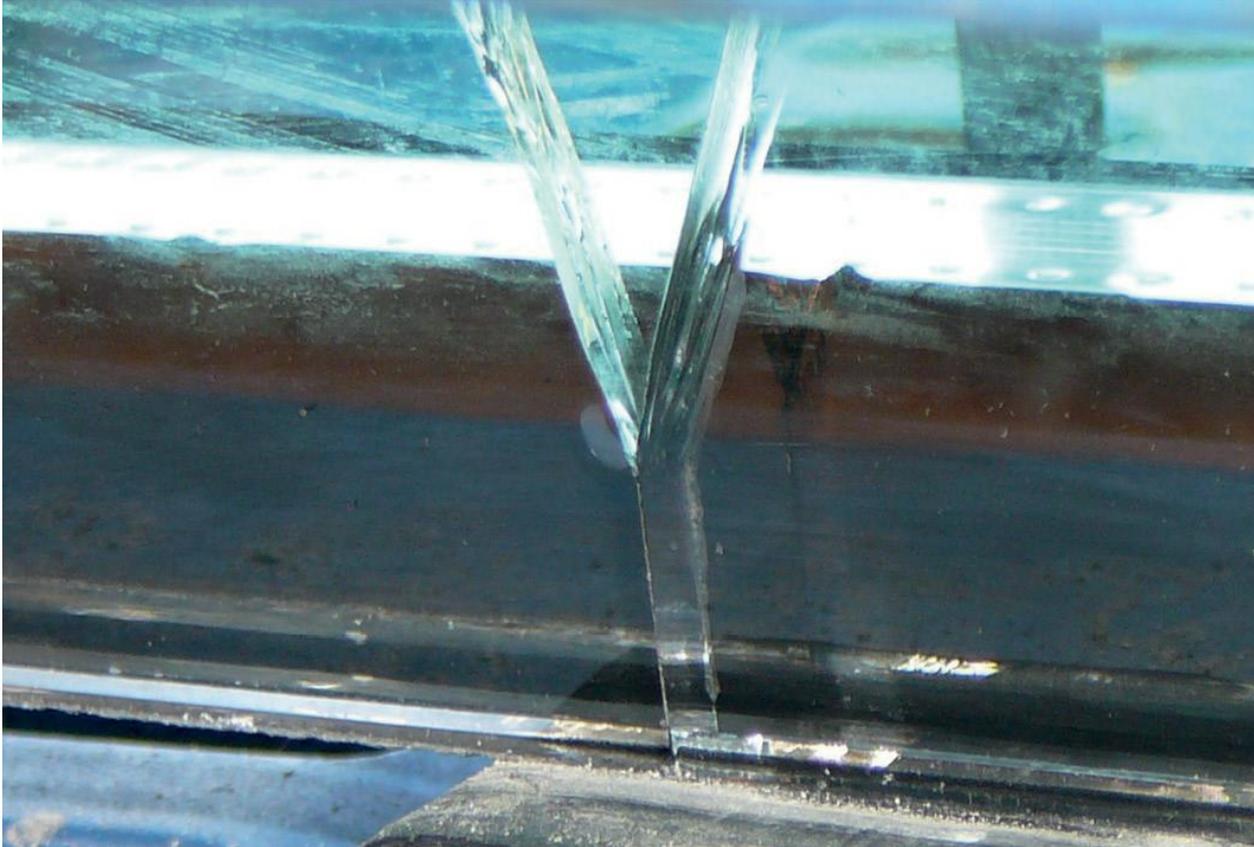
Thermal edge break

Thermal line load - medium to high intensity

Thermal edge breakage, fracture splitting still in the area of the cover by the glass retaining / fixing strip.

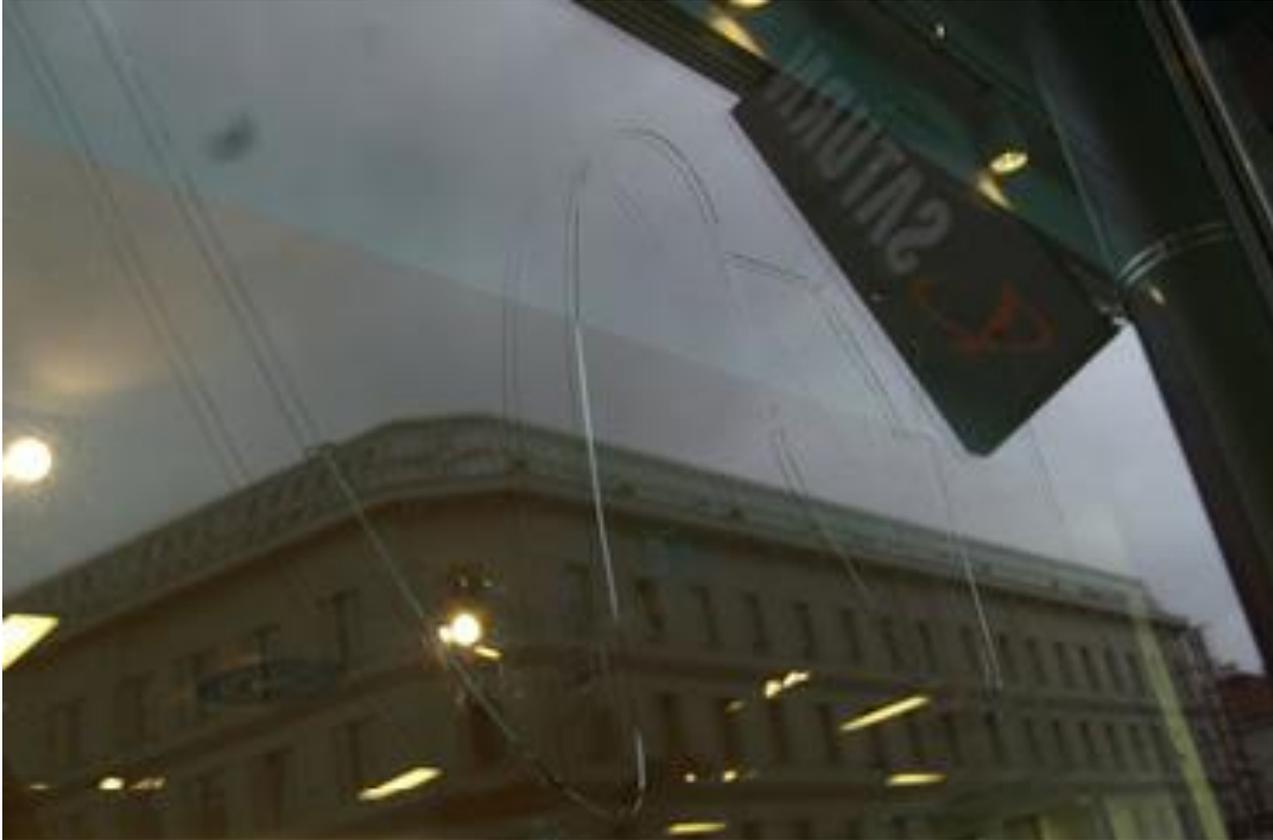
Glass with clearly defined different zones. Thermal breakage line I

Thermal line load - weak to strong intensity

Thermal line break, caused by several strong spotlights for lighting. The fracture runs along the cold / warm zones (stress zones) of the differently heated glass surfaces, which is why the wave form has developed. Similar jump course as on the outside with dark circles pasted or painted discs.
