THERMAL BREAKAGES

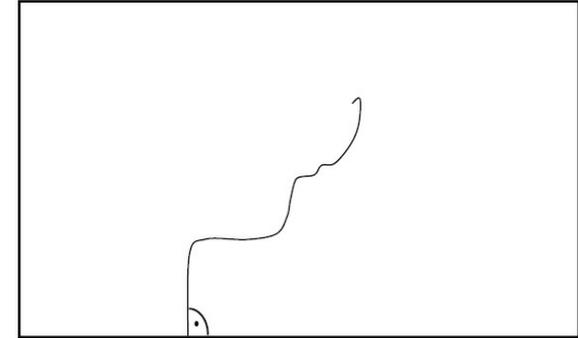
Thermal simple crack

Thermal load — weak / medium intensity

Type of glass	Float glass, ornament glass, drawn glass, laminated glass, wired glass,...
Examples	<ul style="list-style-type: none">• Partial cover on the inside or foil glazing of the pane in direct sunlight;• Too low rebounding;• “LowE” and solar protection glasses (in particular insulating glass) stored in the package without cover in direct sunlight;• Folding or sliding doors made of float glass, pushed one against the other.
Beginning	Entry angle at right angles; Angle of passage at right angles; Notched edges at the inlet are not available.
Run	Change of direction at the cold / warm zone (bend), further course meandering.
Discharge / End	Straight line; often with check marks.

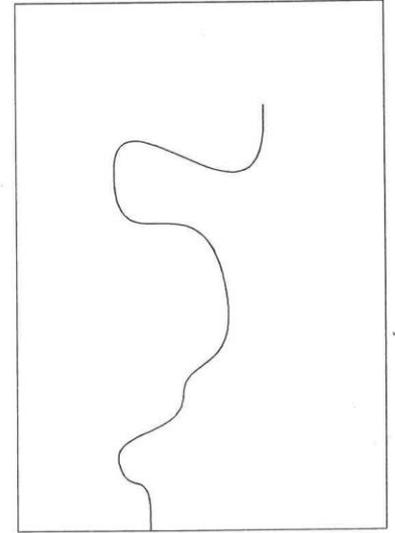
Single crack → Low Stress:

- Single crack suggests a weaker glass edge.
- Less energy was needed to initiate the crack

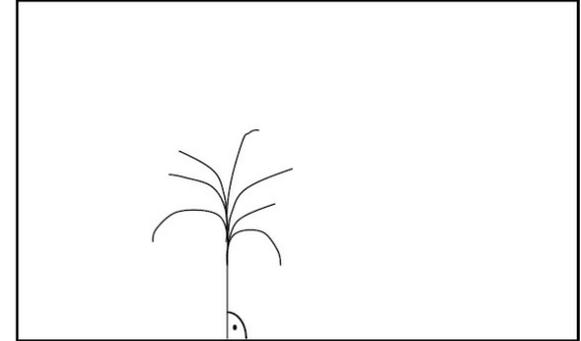
Thermal Palm / Fanning crack

Thermal point or line load - strong intensity

Type of glass	Float glass, ornament glass, drawn glass, laminated glass, wired glass,...
Examples	<ul style="list-style-type: none">• Partial cover on the inside in strong sunlight;• Strong heating in the edge area (blowtorch, hot air blower);• Radiator or heating pipe on the glass pane;• Partial shading on discs bonded with absorbing sun protection foils.
Beginning	Entry angle at right angles; Angle of passage at right angles; Notched edges at the inlet are not available.
Run	Straight inlet; Change of direction at the cold / warm zone; afterwards palm-like fanning.
Discharge / End	Straight lines; Checkmark only very rarely.
Other	Shells in the area rarely; Wallner's lines are often present, especially in the area of the first change of direction.

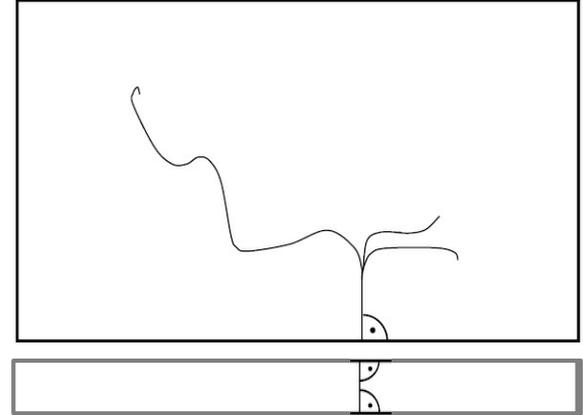
Strong thermal break

Thermal line load - strong intensity

Type of glass	Float glass, ornament glass, drawn glass, laminated glass, wired glass,...
Examples	<ul style="list-style-type: none">• Welding torch directly on the glass pane;• Hot air blower on the glass pane;• Mastic asphalt laying with uneven protective cover of the glass pane;• Folding or sliding doors made of float glass, pushed one against the other;• Inside partial coverage of the pane in direct sunlight;• Partial shading on glass pane with highly absorbent sun protection films.
Beginning	Entry angle at right angles; Angle of passage at right angles; Notched edges at the inlet are not available.
Run	Straight inlet; Change of direction at the cold / warm zone mostly with splitting into several fractures, further course meandering
Discharge / End	Straight lines; Rarely checkmarks.
Other	Possible shells in the area of the first change of direction; Wallner's lines exist, especially in the area of the first change of direction

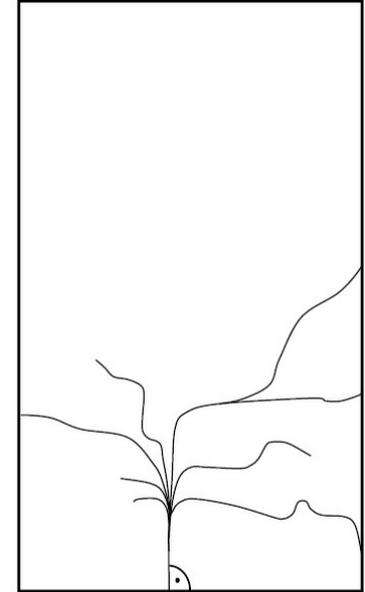
Very strong thermal break

Thermal line load - very strong intensity

Type of glass	Float glass, ornament glass, drawn glass, laminated glass, wired glass,...
Examples	<ul style="list-style-type: none">• Welding torch directly on the glass pane;• Mastic asphalt laying with uneven protective cover of the glass pane;• Hot air blower directly on the glass pane;• Folding or sliding doors made of float glass, pushed one against the other;• Dark inside partial coverage of the pane in direct sunlight;• Partial shading on glass pane with highly absorbent sun protection films.
Beginning	Entry angle at right angles; Angle of passage at right angles; Notched edges at the inlet are not available.
Run	Straight inlet; Change of direction and multiple fanning at the cold / warm zone; further course meandering.
Discharge / End	Straight lines; Rarely checkmarks.
Other	Possible shells in the area of the first change of direction; Wallner's lines exist, especially in the area of the first change of direction

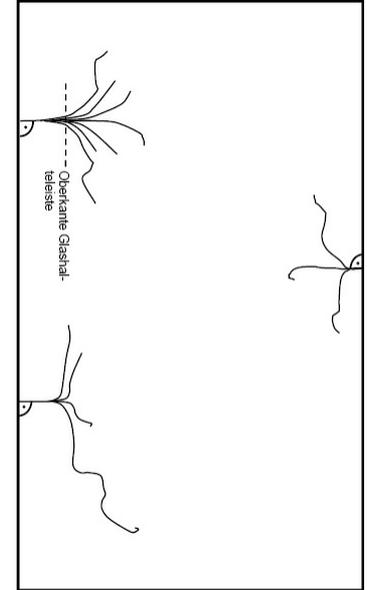
Thermal line load - medium to high intensity

Type of glass	Float glass, ornament glass, drawn glass, laminated glass, wired glass,...
Examples	<ul style="list-style-type: none"> • Very low rebate condition; • significantly higher coverage on the inside than on the outside; • inside partial coverage of the pane in direct sunlight; • pasted slices.
Beginning	Entry angle at right angles; Angle of passage at right angles; Notched edges at the inlet are not available.
Run	Straight inlet; Change of direction at the cold / warm zone usually with splitting into several fractures, often directly over glazing bead, further course straight or meandering
Discharge / End	Straight lines; Rarely checkmarks.
Other	Possible shells in the area of the first change of direction; Wallner's lines exist, especially in the area of the first change of direction

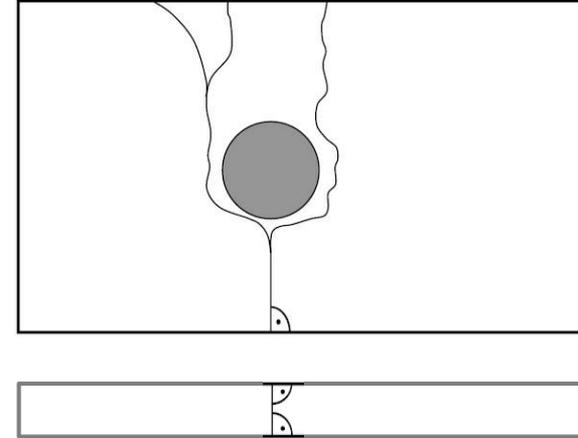
Glass with clearly defined different zones. Thermal breakage line I

Thermal line load - weak to strong intensity

Type of glass	Float glass, ornament glass, drawn glass, laminated glass, wired glass,...
Examples	<ul style="list-style-type: none">• Partial coverage by means of interior decoration directly on the glass pane;• dark areas (sticker, advertisement) on the glass pane;• large plant leaf inside directly on the glass,...
Beginning	Entry angle at right angles; Angle of passage at right angles; Notched edges at the inlet are not available.
Run	Straight inlet, direction change at the cold / warm zone, splitting at cold / warm zone possible.
Discharge / End	straight; no check mark; mostly breakaway
Other	Shells in the area often present; Wallner's lines exist, especially in the area of the first change of direction.

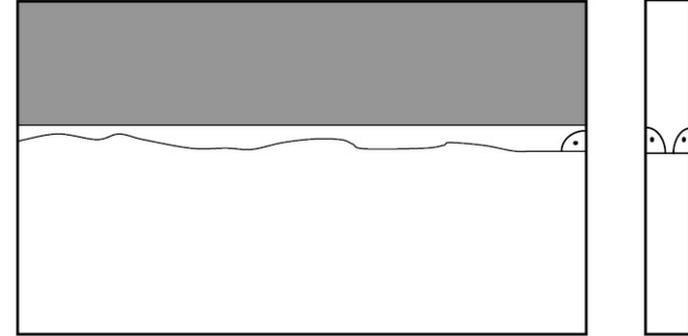
Glass with clearly defined different zones. Thermal breakage line II

Thermal line load - weak to strong intensity

Type of glass	Float glass, ornament glass, drawn glass, laminated glass, wired glass,...
Examples	<ul style="list-style-type: none">• Partial darkening by means of internal blinds directly to pane;• Partial coverage by means of interior decoration directly on the pane;• Drop shadow due to roof overhang; dark areas (stickers, foils, advertising or similar) on the glass.
Beginning	Entry angle at right angles; Angle of passage at right angles; Notched edges at the inlet are not available.
Run	Along cold / warm zone; meandering course.
Discharge / End	straight; no check mark;
Other	rarely shells in the area; Wallner's lines possible.

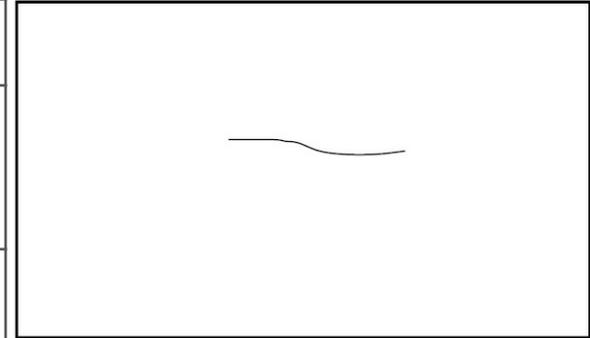
Thermal worm crack

Thermal point load - very strong intensity

Only for very large and very thick glass panes

Type of glass	Float glass, drawn glass, laminated glass – all with high thickness
Examples	<ul style="list-style-type: none">• Welding torch on glass surface;• Hot air blower on glass surface;• Strong punctual warming in the glass surface of a very large, thick shop window
Beginning	Within the glass surface; no beginning at the glass edge; no distinction between start and end possible.
Run	Snake- or worm-like in the glass pane center without major changes of direction.
Discharge / End	Within the glass surface; no beginning at the glass edge; no distinction between start and end possible.
Other	Often not recognizable from every angle; Wallner's lines possible
